iMuto 20000mAh Portable Charger Teardown

The iMuto Taurus X4 charger wasn't meant to be disassembled. The micro USB charging port broke on my device, so I decided to use brute force to look inside.

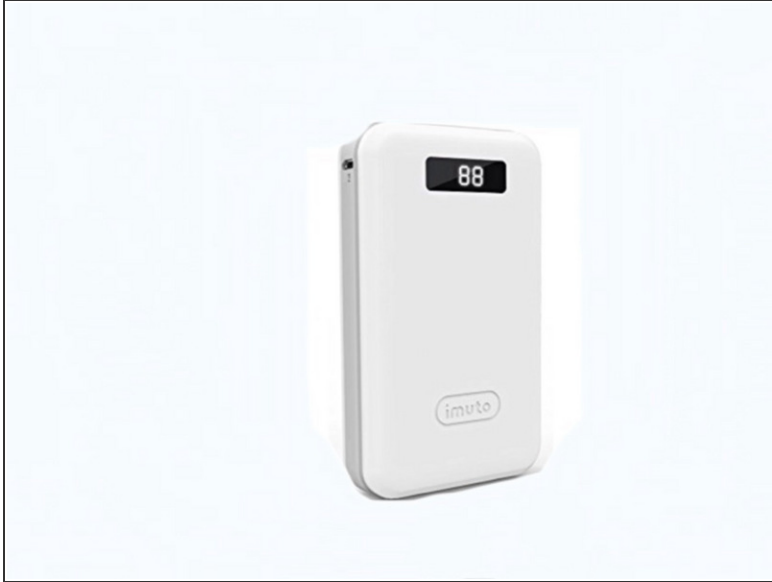
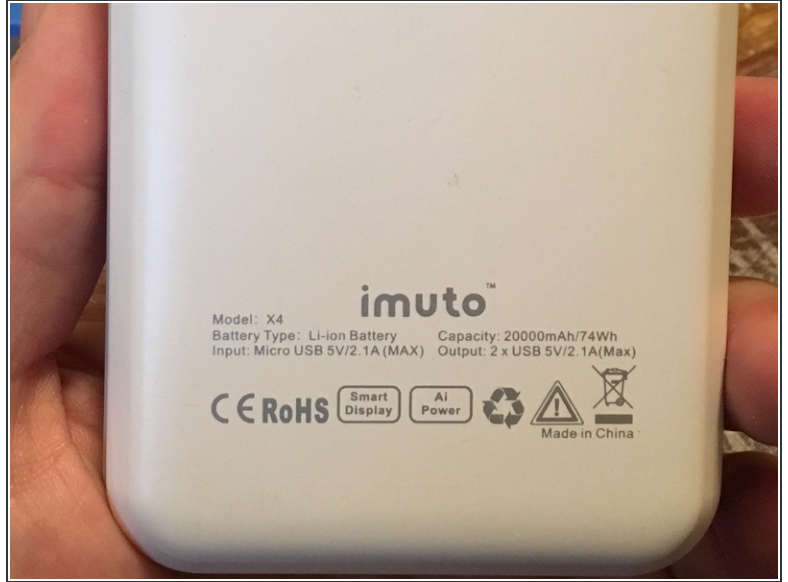
Step 1 — The iMuto 20,000mAh Portable Charger

- The iMuto 20,000mAh Portable Charger

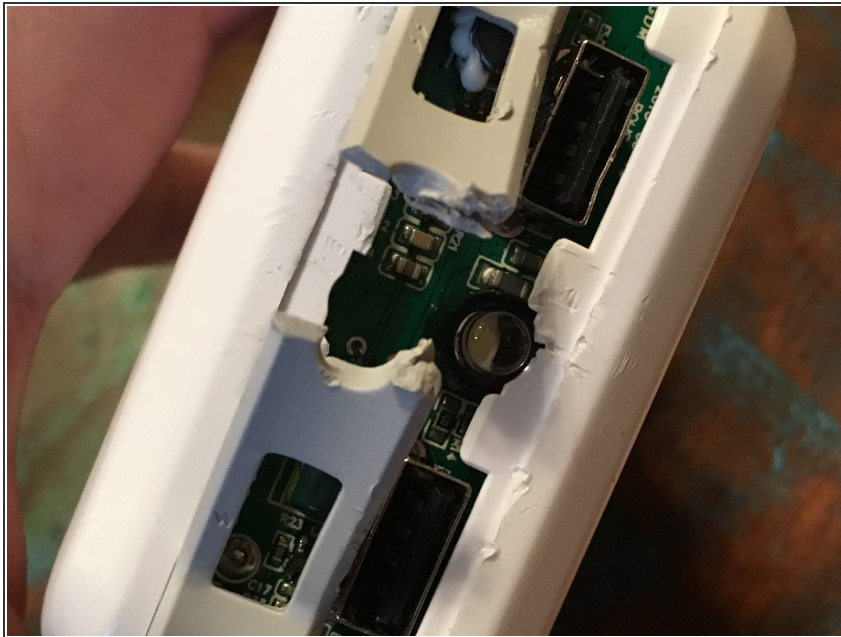
Step 2 — Chop Chop!

- Using micro screwdrivers, needle-nose pliers, and a diagonal cutter... Leverage and pry the plastic band until you can chop it with the diagonal cutters.

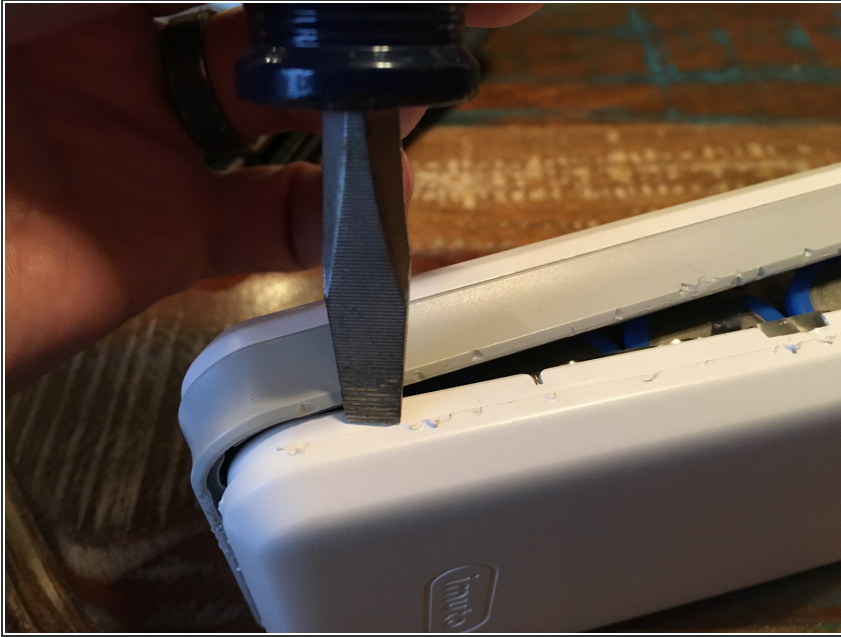
Step 3 — Pry off the case top with a screwdriver.

- Using a screwdriver, wedge between the plastic band and the case top, then use a twisting motion in the direction like you would driving a screw to work your way around the case, prying the case top from the middle band of plastic.

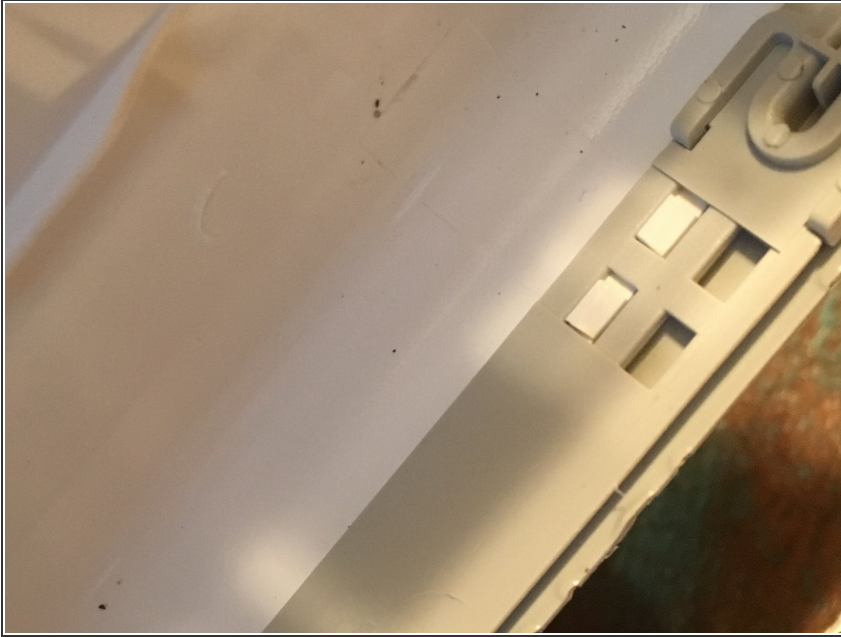
Step 4 — This Charger Isn't Meant For Disassembly.

- Once you ungracefully chop and pry the case off of the charger, you can see why it is not meant to be disassembled or repaired. The case has clips that hold the case together and these clips can't be easily unclipped.
